HIGH RESOLUTION SAR IMAGING EMPLOYING GEOMETRIC FEATURES FOR EXTRACTING SEISMIC DAMAGE OF BUILDINGS

L. P. Cui, X. Q. Wang*, A. X. Dou, X. Ding

Institute of Earthquake Forecasting, China Earthquake Administration, Beijing, 100036, CHINA
*wangxiaoq517@163.com

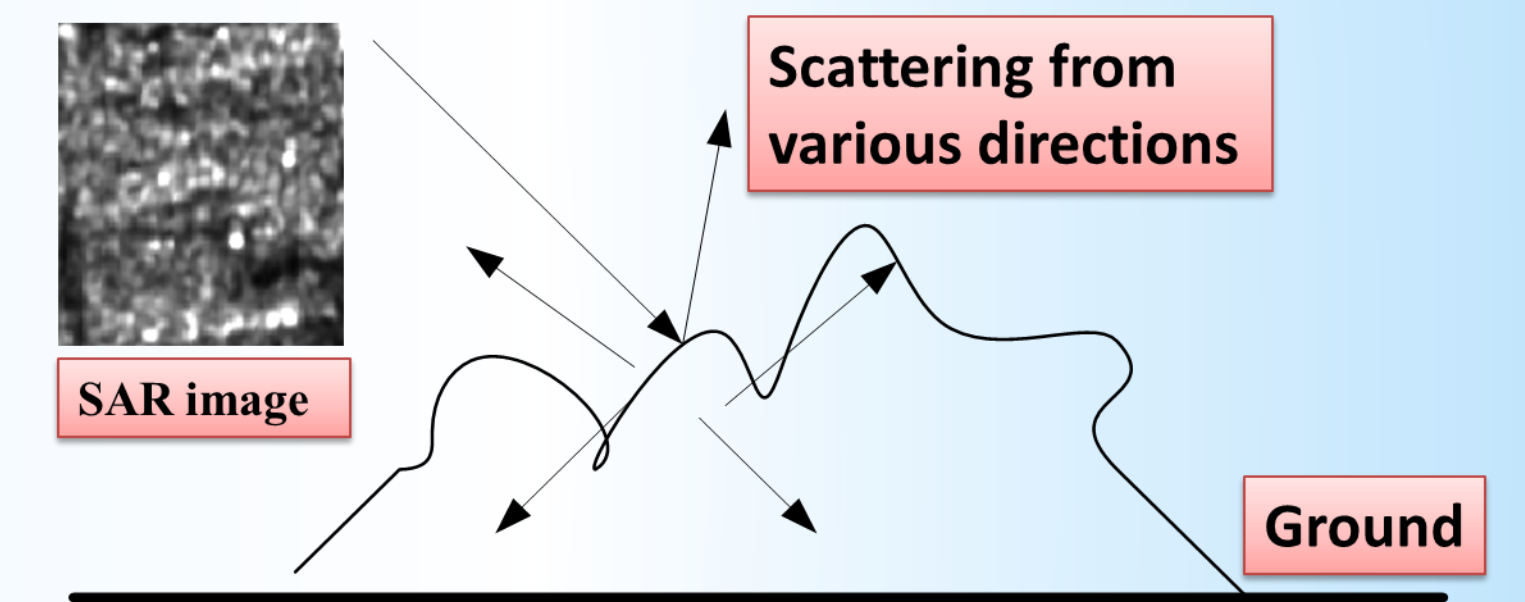
Fig 2 SAR scattering features of collapsed building

The building imaging is affected by layover, double bounce scattering and shadow etc. on the slant range SAR images. For a building model with uniform surface located in a flat ground, if the aircraft with SAR sensor flights parallel to the direction of building, then there will be three SAR imaging models according to the building height (h), width (w) and the incidence angle of SAR sensor, as shown in Figure 1 & 2.
